## Technical Report

**Client : Hotel Marhaba Sousse**  
**[www.marhaba-resort.com](http://www.marhaba-resort.com)**

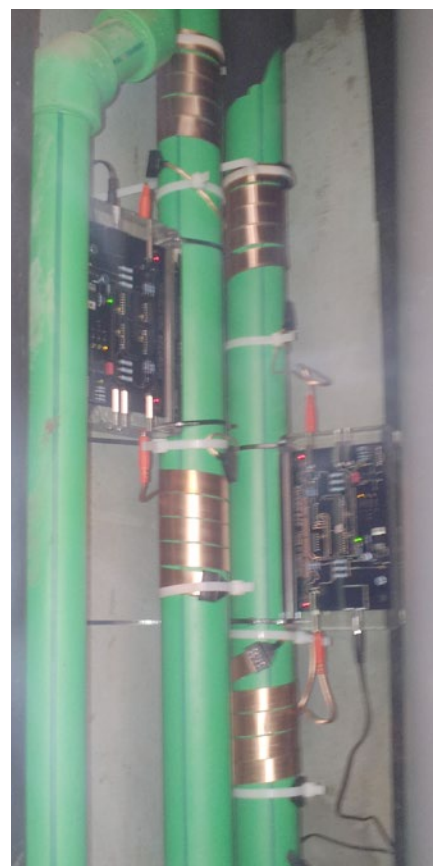
- In the technical area (hot water tanks, boiler and heat exchanger)
- In the technical duct, on two pipes that supply hot and cold water to part of the rooms in order to remove scale and rust from the taps and sanitary accessories of the rooms

2 x Vulcan S10

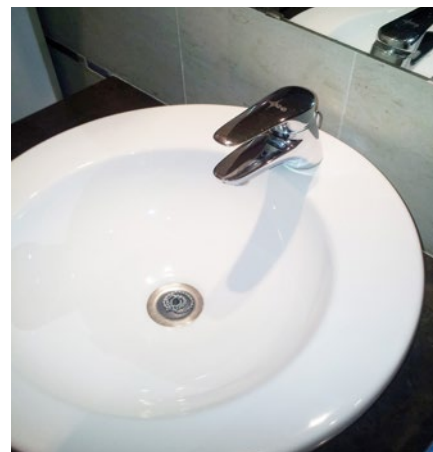
After an eight-week follow-up by us, accompanied by the Head of Maintenance, visual observation on the hot water tank and pictures. We found that the resistance and the walls of the tank were clean. The scale had loosened and fallen off, and it was a friable proof of the effect of the Vulcan treatment.

Concerning the rooms that have been treated. We found that the rust had disappeared and that the taps were clean as well as the shower and sanitary accessories, unlike the untreated rooms. The Vulcan treatment was effective in twenty-four out of twenty-four. The treated water will continue over time to de-clog layer by layer the scale on the entire installation.

After Vulcan
