The Cooling Systems in the Poultry Farm

Installation details

Location: 3 chicken farms in Morocco

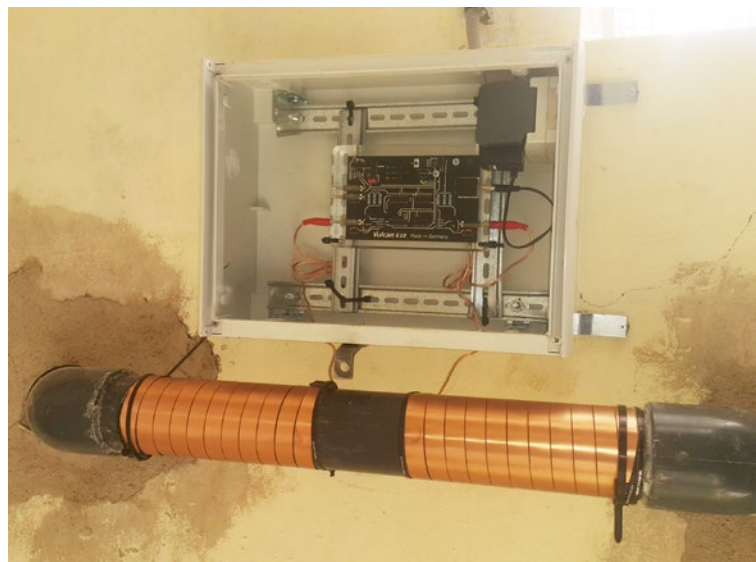
Vulcan S10 was installed in the water main to treat 6 cooling systems in 3 chicken farms.

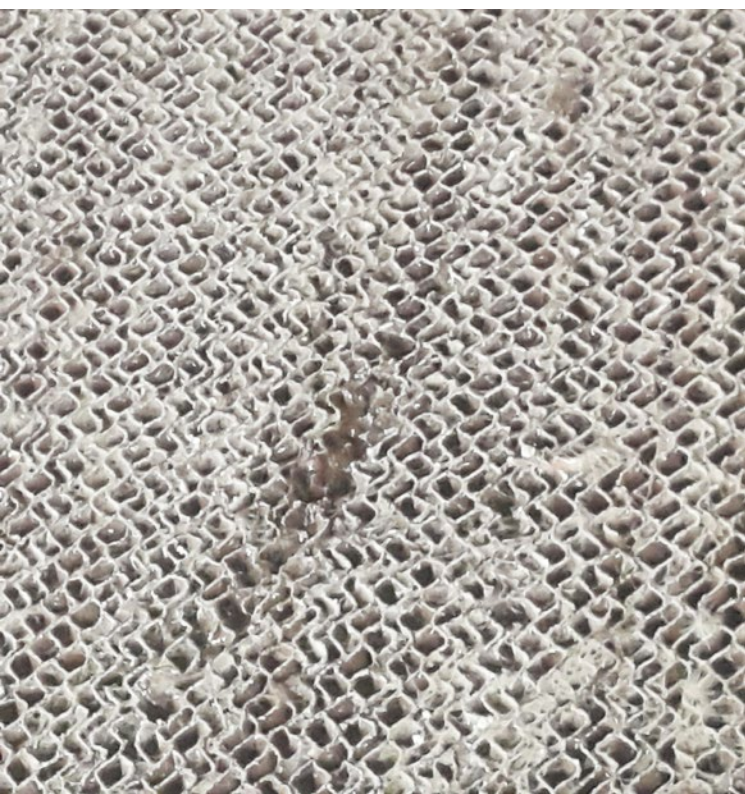
Without any water treatment, the scale was hard like stones, which had not been cleaned for more than 5 years.

Result: The customer built the new cooling tower pads to test the Vulcan effects and compared the old pads which had not been cleaned for more than 5 years.

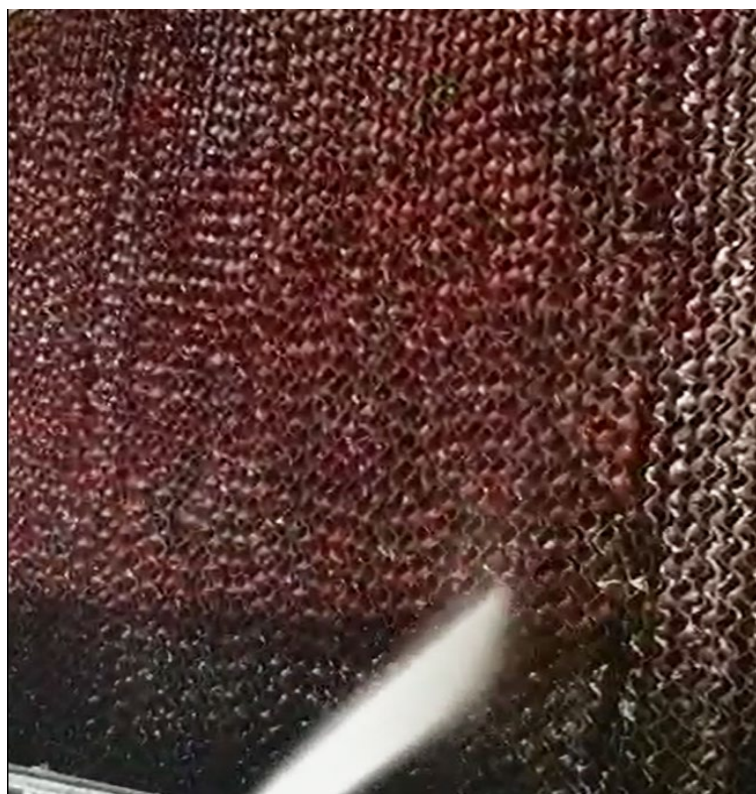
After Vulcan S10 had been installed for 2 weeks, the old scale had been softer, and the new scale had formed as powder. The new scale was easy to clean, and the old scale took more time to clean up with a water gun.

- For the new pads, the new scale formed like powder, and it can be eliminated very easily.
- For the old pads, it took longer time to clean the old scale with a water gun.
